Report No. R0180  
Printed: January, 1981  
Prepared at: Humboldt  
ISSN 0383-3445

# Research Report 238

## Combine Modifications

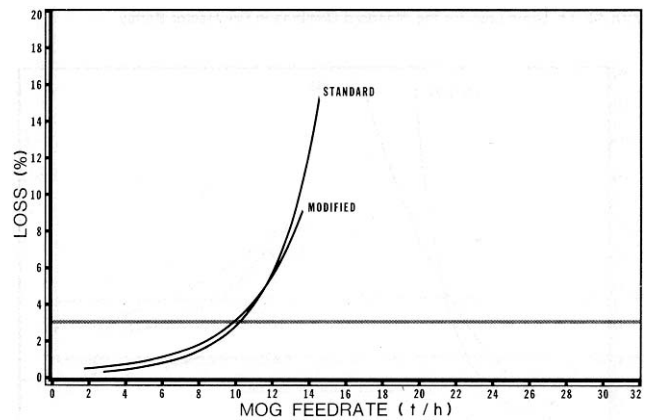
FIGURE 8. Capacity Comparison in Tough Neepawa Wheat.

Since the combine modifications had very little effect on capacity (FIGURE 8), but increased grain damage, they reduced overall combine performance in tough Neepawa wheat.

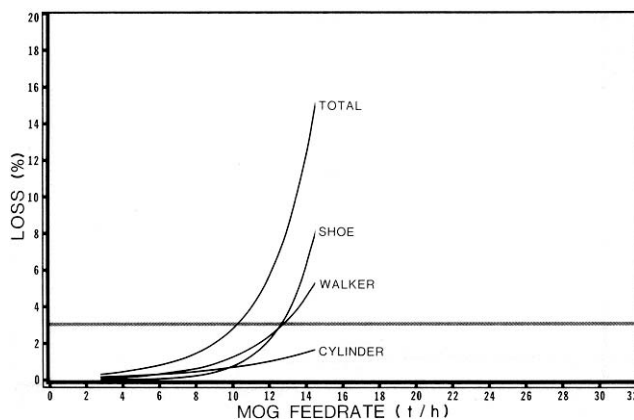
FIGURE 7. Grain Loss for the Standard Combine in Tough Neepawa Wheat.

**Tough Neepawa Wheat:** The modified combine (FIGURE 6) had straw walker, shoe and cylinder losses nearly equal to those of the standard combine (FIGURE 7). The wider front concave clearance (APPENDIX II) and the blanked front concave intervals of the modified combine reduced straw breakup and increased straw walker efficiency, but simultaneously reduced concave separation efficiency, discharging more grain to the walkers. The net result was no reduction in straw walker loss. Since shoe losses were not significantly different, shoe modifications did not improve shoe performance. Cylinder losses were similar on both combines. The slightly higher cylinder speed used on the modified combine and blanking reduced unthreshed heads, but the wider front concave clearance increased unthreshed heads with the net result that concave and cylinder modifications did not improve threshing efficiency. Grain damage was higher on the modified combine (FIGURE 9) due to the higher cylinder speed and concave blanking.

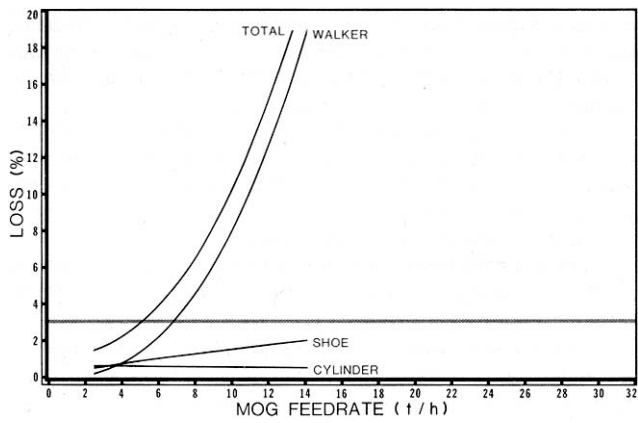
FIGURE 10. Grain Loss for the Modified Combine in Dry Hector Barley.

**Dry Hector Barley:** The modified combine (FIGURE 10) had higher straw walker losses and higher shoe losses, but slightly lower cylinder loss than the standard combine (FIGURE 11). The wider front concave clearance (APPENDIX II) and the blanked concave intervals on the modified combine greatly reduced concave separation efficiency, discharging much more grain onto the walkers, increasing walker loss. The modified combine had higher shoe losses than the standard combine, and the shoe modifications actually resulted in increased shoe loss. Cylinder

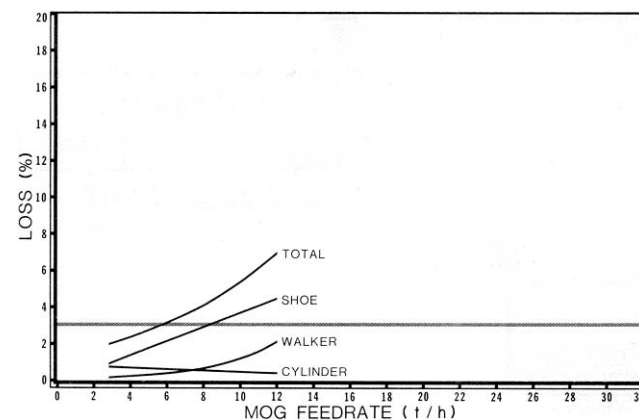
FIGURE 19. Grain Loss for the Standard Combine in Candle Canola.

**Dry Candle Canola:** The modified combine (FIGURE 18) had higher straw walker loss than the standard combine (FIGURE 19), but had lower shoe and cylinder losses. Lower shoe loss for the modified combine was attributed to the effect of the wire mesh installed on the top on the straw walkers, and was not due to cylinder, concave, or shoe modifications. The mesh reduced the amount of trash falling through the walkers onto the shoe, thereby reducing the shoe load. The walker loss was increased due to more walker retention of broken stems and pods. The increased walker loss was however less than the decrease in shoe loss. Since the modified combine was operated at a much higher cylinder speed than the standard machine, (APPENDIX II), cylinder loss was low. The net result was that the standard combine had about 30% less capacity than the modified combine in this crop (FIGURE 20).

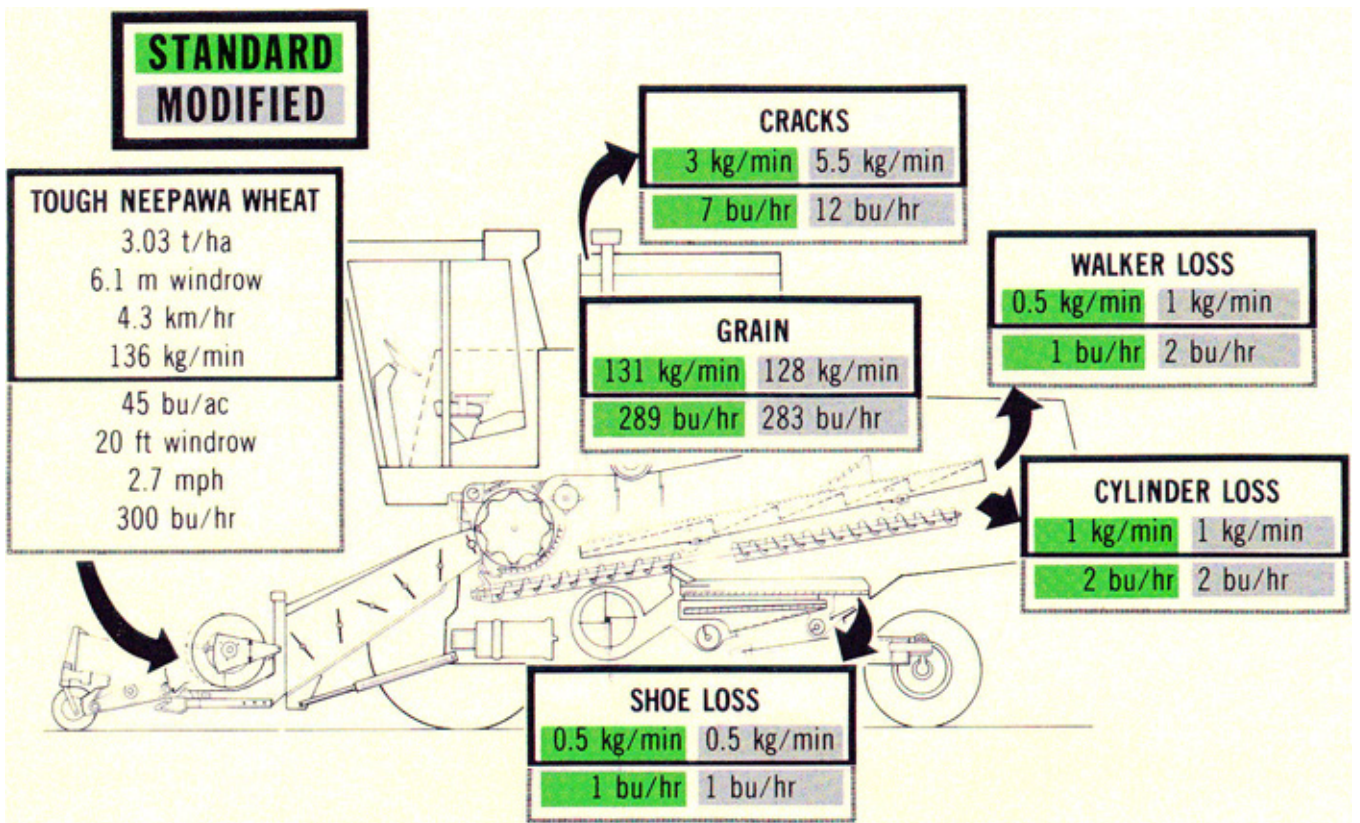
FIGURE 23. Combine Lossrates in Tough Neepawa Wheat.

FIGURE 23 also shows similar walker, shoe and cylinder lossrates for the standard and modified combines in tough Neepawa wheat. The modified combine damaged more grain than the standard combine, and as a result saved less grain than the standard combine. Combine modifications reduced overall combine performance in tough Neepawa wheat.

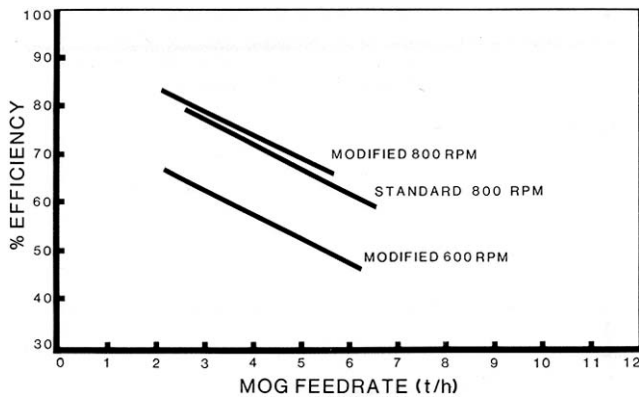
**FIGURE 32.** Concave Separation Efficiency for the MF 750 Concave in Barley.

At the 600 rpm speed, as recommended in "Combine Settings for Better Harvesting", concave separation efficiency was 15% lower for the modified concave than for the standard concave. This reduction in efficiency was largely due to cylinder speed (FIGURE 32). When the modified assembly was operated at 800 rpm concave separation efficiency was identical to that of the standard assembly operated at the manufacturer's recommended 800 rpm speed.

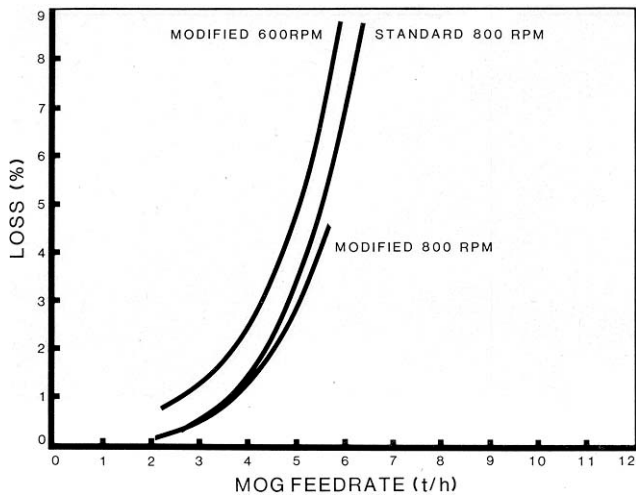
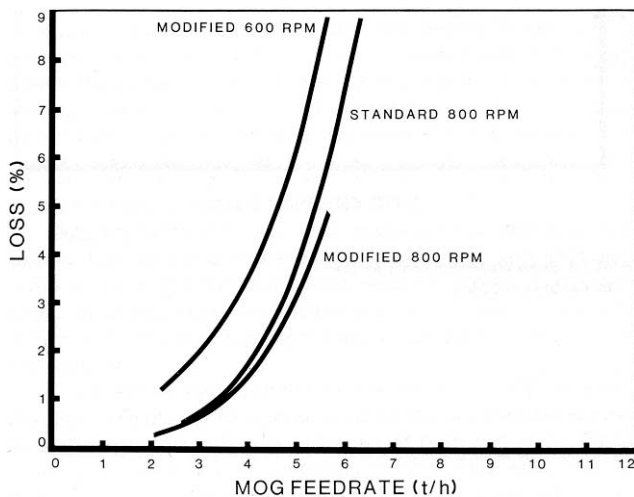
FIGURE 34. Grain Loss for the MF 750 Concave in Barley: (a) Walker Loss, (b) Cylinder Loss, (c) Total Loss.

Both straw walker loss and cylinder loss were significantly higher with the modified assembly operated at 600 rpm than for the standard assembly (FIGURE 34). The full modifications caused a 21% decrease in capacity. When the modified assembly was operated at 800 rpm, capacity of the modified assembly was similar to the capacity of the standard assembly.

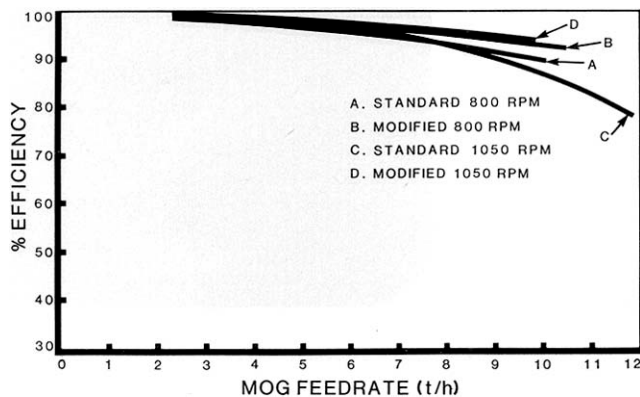
FIGURE 37. Straw Walker Efficiency for the JD 6600 Concave in Wheat.

Concave modifications, combined with low cylinder speeds, increased straw walker efficiency at high feedrates (FIGURE 37), as a result of reduced straw breakup. Although straw walker efficiency increased, this was offset by a decrease in concave separation efficiency, with the net result that straw walker losses were nearly equal for both the standard and modified assemblies.

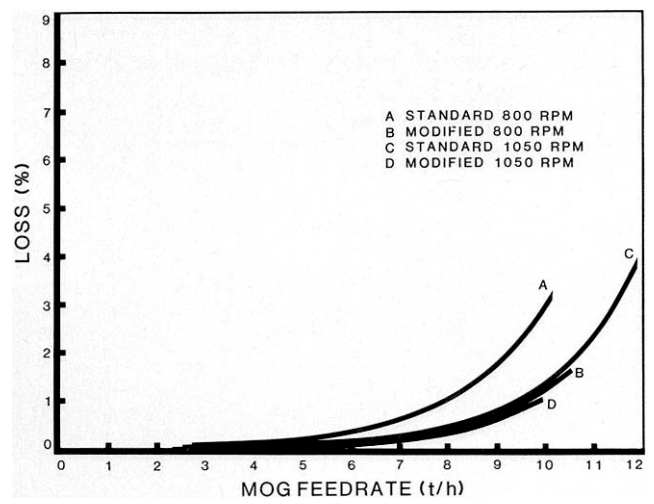
FIGURE 38. Grain Loss for the JD 6600 Concave in Wheat: (a) Walker Loss, (b) Cylinder Loss, (c) Total Loss.

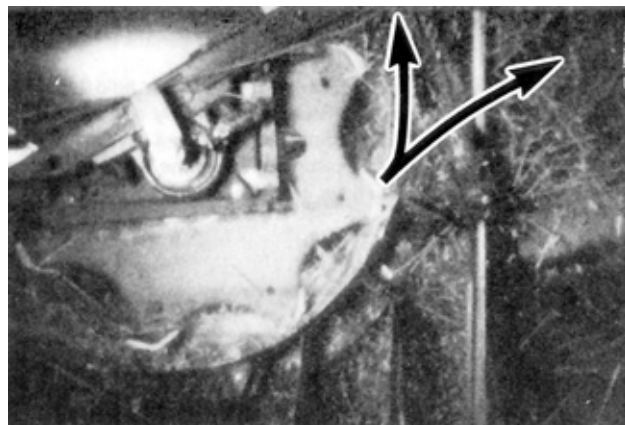
FIGURE 41. Crop Discharge to the Rear Beater (Modified).

Modifying the JD 6600 concave resulted in severe backfeeding at moderate to high feedrates. High speed photography showed that with the standard concave, the cylinder discharge hit the centre of the beater (FIGURE 40). With the modified concave, the cylinder discharge hit the front tip of the beater causing backfeeding (FIGURE 41). Because of this problem, combined with no beneficial effects, concave modification should be avoided.
